SCD CASE STUDY

Treatment Considerations for Implant Rehabilitation

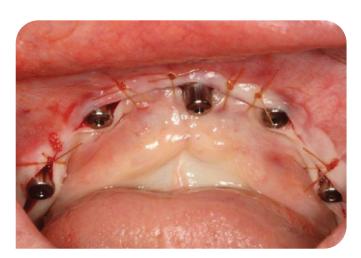
FIG. 3a Implant placement

- LA Used: Articaine 4% 1:100000 Adrenalin 10.8 mls inferior dental block Quadrant 3 Quadrant 4
- Buccal flap raised Performed osteotomy to insert implant
- 35: MIS 3.75 x 8mm Seven internal hex LOT:WO2196421 Torque 50Ncm
- 45: MIS 3.75 x 8mm Seven internal hex LOT:W13000918 Torque 50Ncm
- Coverscrew placed
- Sutured using Chromic Gut 5/0

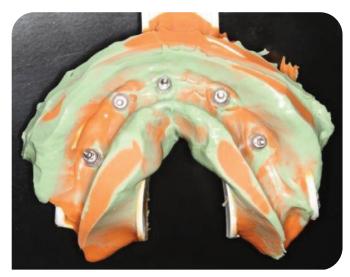
FIG. 4b Occlusal view of impression copings

- Removed healing abutments and placed MIS pick up impression copings into 45, 43, 31, 33, 35
- Lower impression using Affinis® (COLTENE) heavy and light body PVS
- Replaced healing caps
- Took upper alginate for special tray and bite block for new Full Upper Denture
- A combination approach of both screw and cement-retained restorations both in the intermediate prosthesis and the final porcelainfused-to-metal final restorations was employed
- Fixed provisionalisation was deemed necessary to ascertain functional, aesthetic and phonetic performance
